Promoting Adaptation to Changing Coasts (PACCo)

Lower Otter restoration project – case study of the disused tip

Date: December 2022

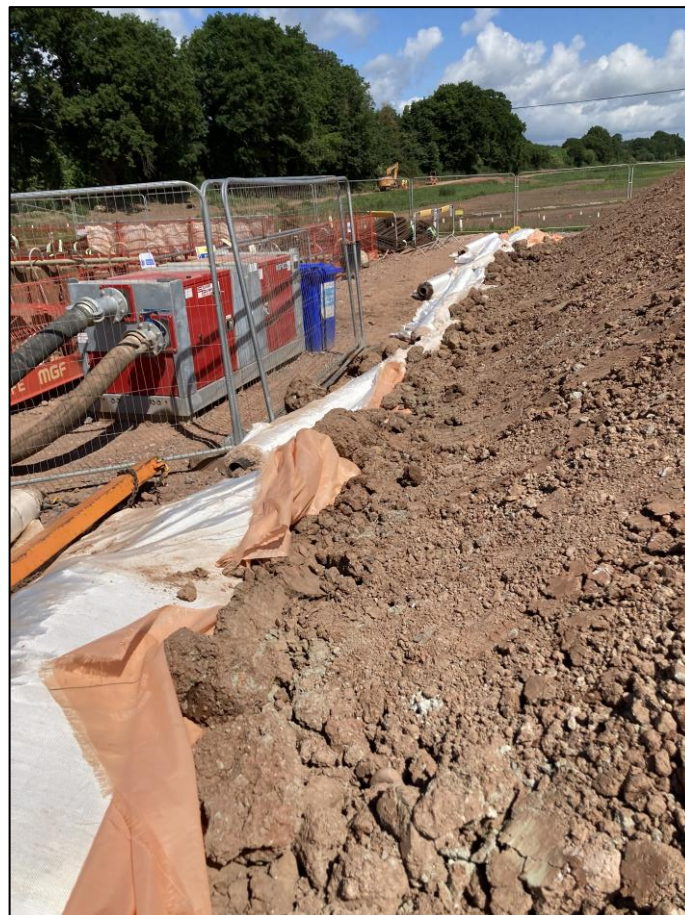
Photo 1. Orange warning geotextile under the new bank (Source: Environment Agency)

The New South Farm Road was raised and built partly on the northern boundary of the landfill by importing and compacting cohesive soil². The new 2.5m raised road capped this section of the tip whilst providing a new road for the local community, which was raised well above the floodplain. The design of the new bank eliminated the need for deep excavation and therefore reduced the disturbance of waste. A geotextile warning layer was placed over the ground to ensure any future work does not disturb the landfill (Photo 1).

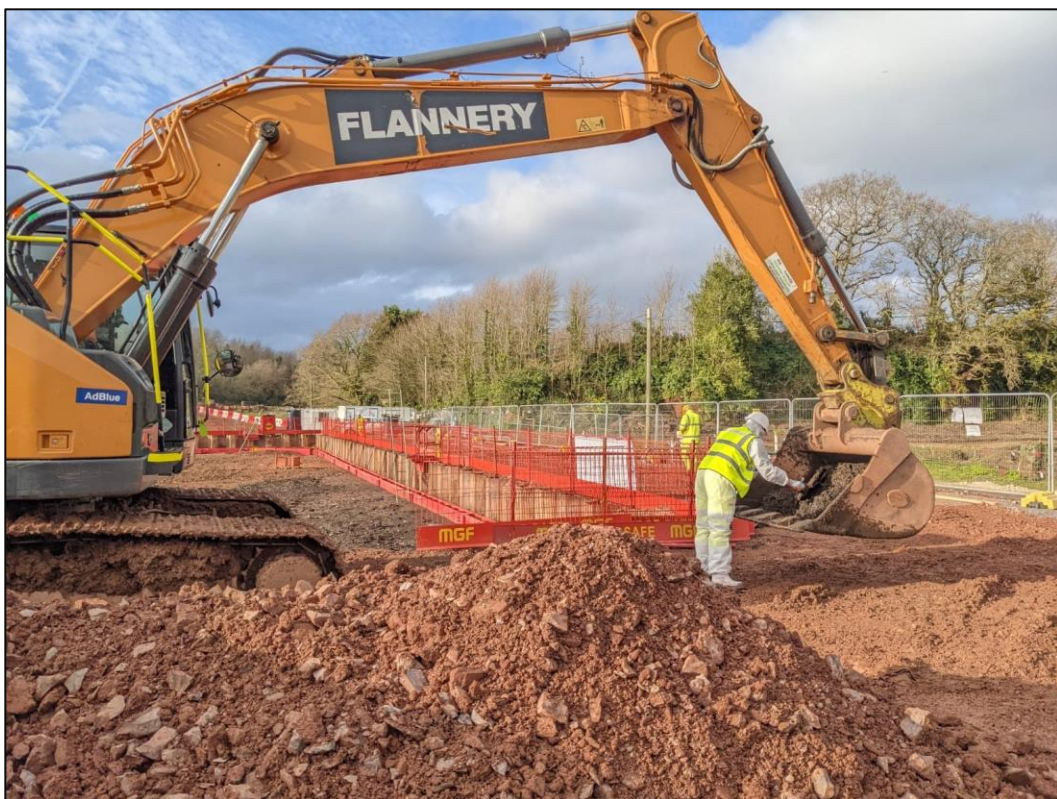
Photo 2. Excavated material controlled for asbestos (Source: Kier)

The earth work at the bridge location was carried out following relevant regulations (Photo 2 and 3). A specialist contractor was used for this operation. The ground was dampened prior to work starting to eliminate any airborne materials. All employees involved in the work were trained to follow the required regulations. The area was isolated from the site and was secured with specific signage. The contractors wore special PPE (personal protective equipment) as required by the CAR2012, such as respiratory protection and protective coveralls which provide defence against airborne particles and fibres, splash and spray.

A decontamination unit was set up near the area of work and a dust suppression system installed to mitigate the risk of airborne particles being generated by the excavation.
